REPORT NO: 12087
10 November 2017

COMPRESSION TEST REPORT

Prepared for:
Multipod International

Specimen: Multipod International – Paver pedestal
Test Procedure: Procedure EQP019
Test Date: 08/11/2017
Load rate: 1mm/sec
Platen size: 250mm

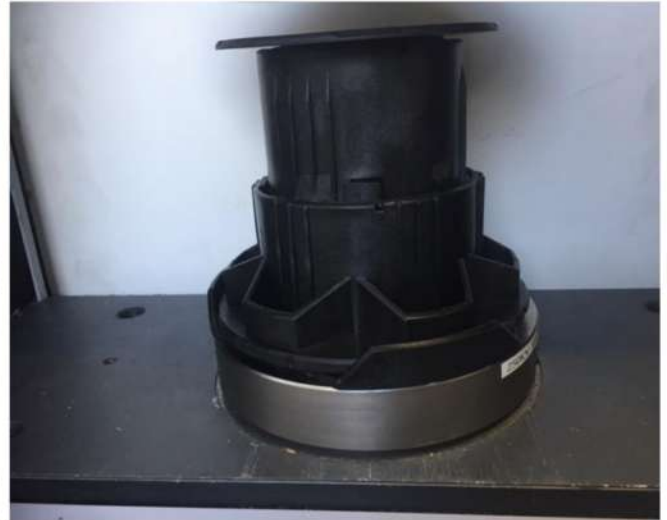
Figure 2: Sample 2 during test

Test	Specimen	Sample diameter (mm)	Sample height (mm)	Maximum force (N)	Maximum force (Kg)	Failure point	Pedestal configuration
1	Multipod International – 003 Paver pedestal	195	95	172997*	17635*	NOTE 1	Fully lowered position, Figure 1.
2		195	168	10506	1071	Central column thread	Lower column raised, upper column collapsed, screw retracted, Figure 2.
3		195	251	8076	823	Central column thread	Lower column raised, upper column raised, screw retracted, Figure 3.
4		195	272	8315	848	Top screw thread	Lower column raised, upper column raised, screw partially extended, Figure 4.
5		195	309	7613	776	Top screw thread	Lower column raised, upper column raised, screw fully extended, Figure 5.
6	Multipod International – 001 Paver pedestal	195	18	207108*	21112*	NOTE 1	Fully lowered position, Figure 6.
7		195	35	33709	3436	NOTE 1	Fully raised position, Figure 7.

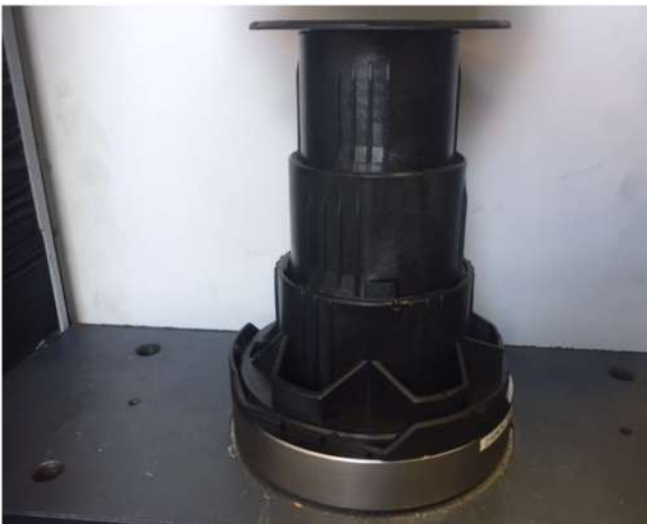
Figure 3: Sample 3 during test

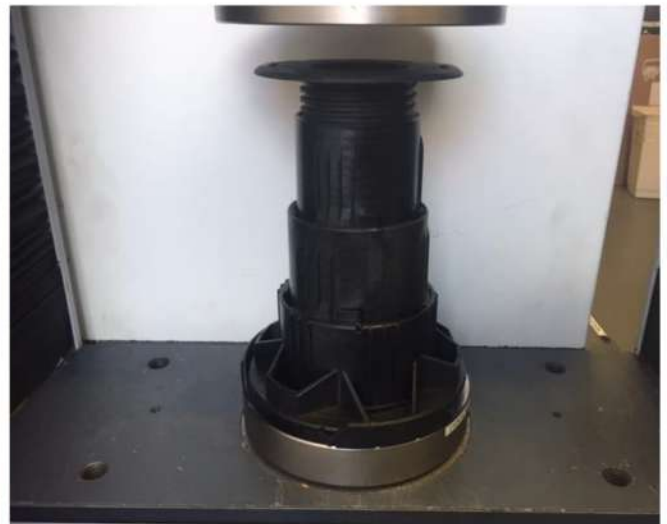
Figure 4: Sample 4 during test

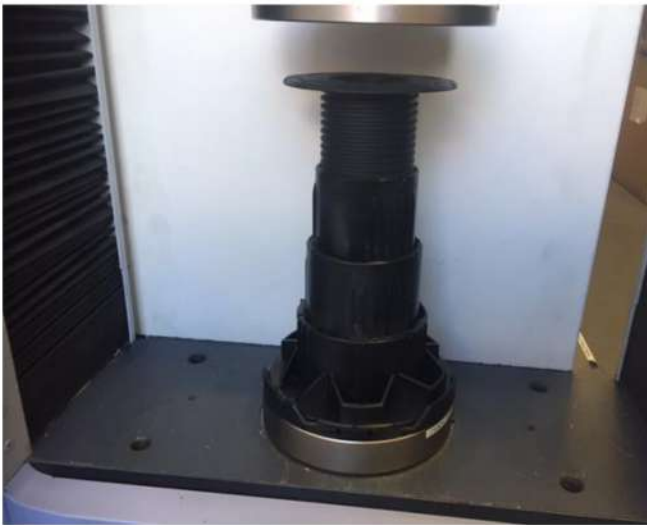
Figure 5: Sample 5 during test

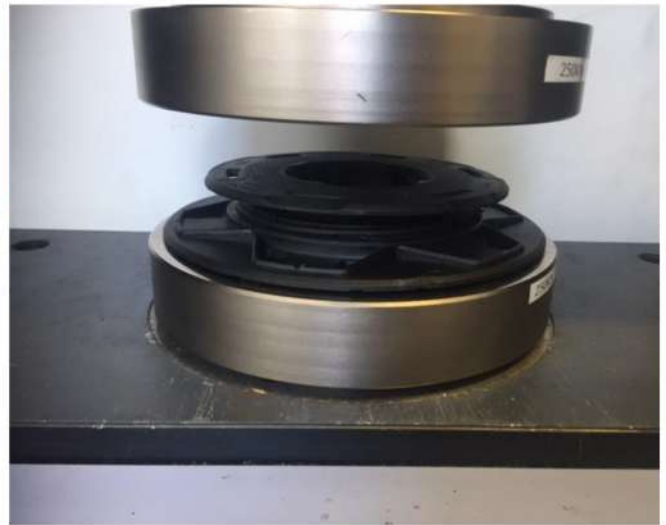
Figure 6: Sample 6 during test

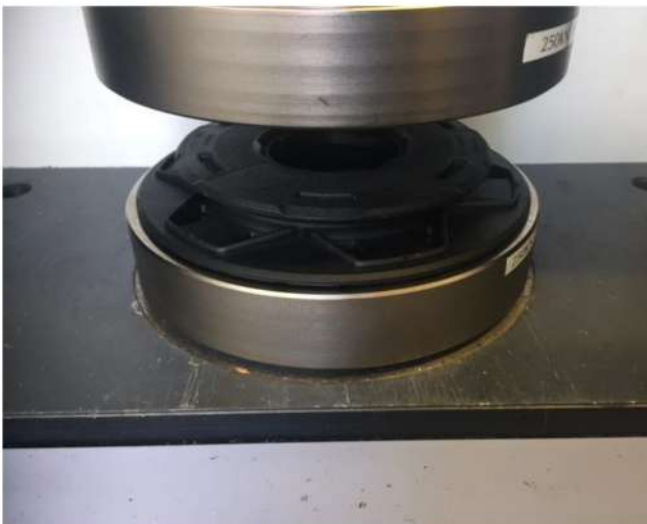
Figure 7: Sample 7 during test
